**Final Proposed Plan for  
25 Picatinny Sites within  
PICA 001, 006, 022, 085,  
143, 146, 163, 171, 192,  
and 199**

**U.S. Army Garrison  
Picatinny Arsenal,  
New Jersey**

**February 2013**

## NO FURTHER ACTION WITH MONITORING OF LAND USE PROPOSED PLAN

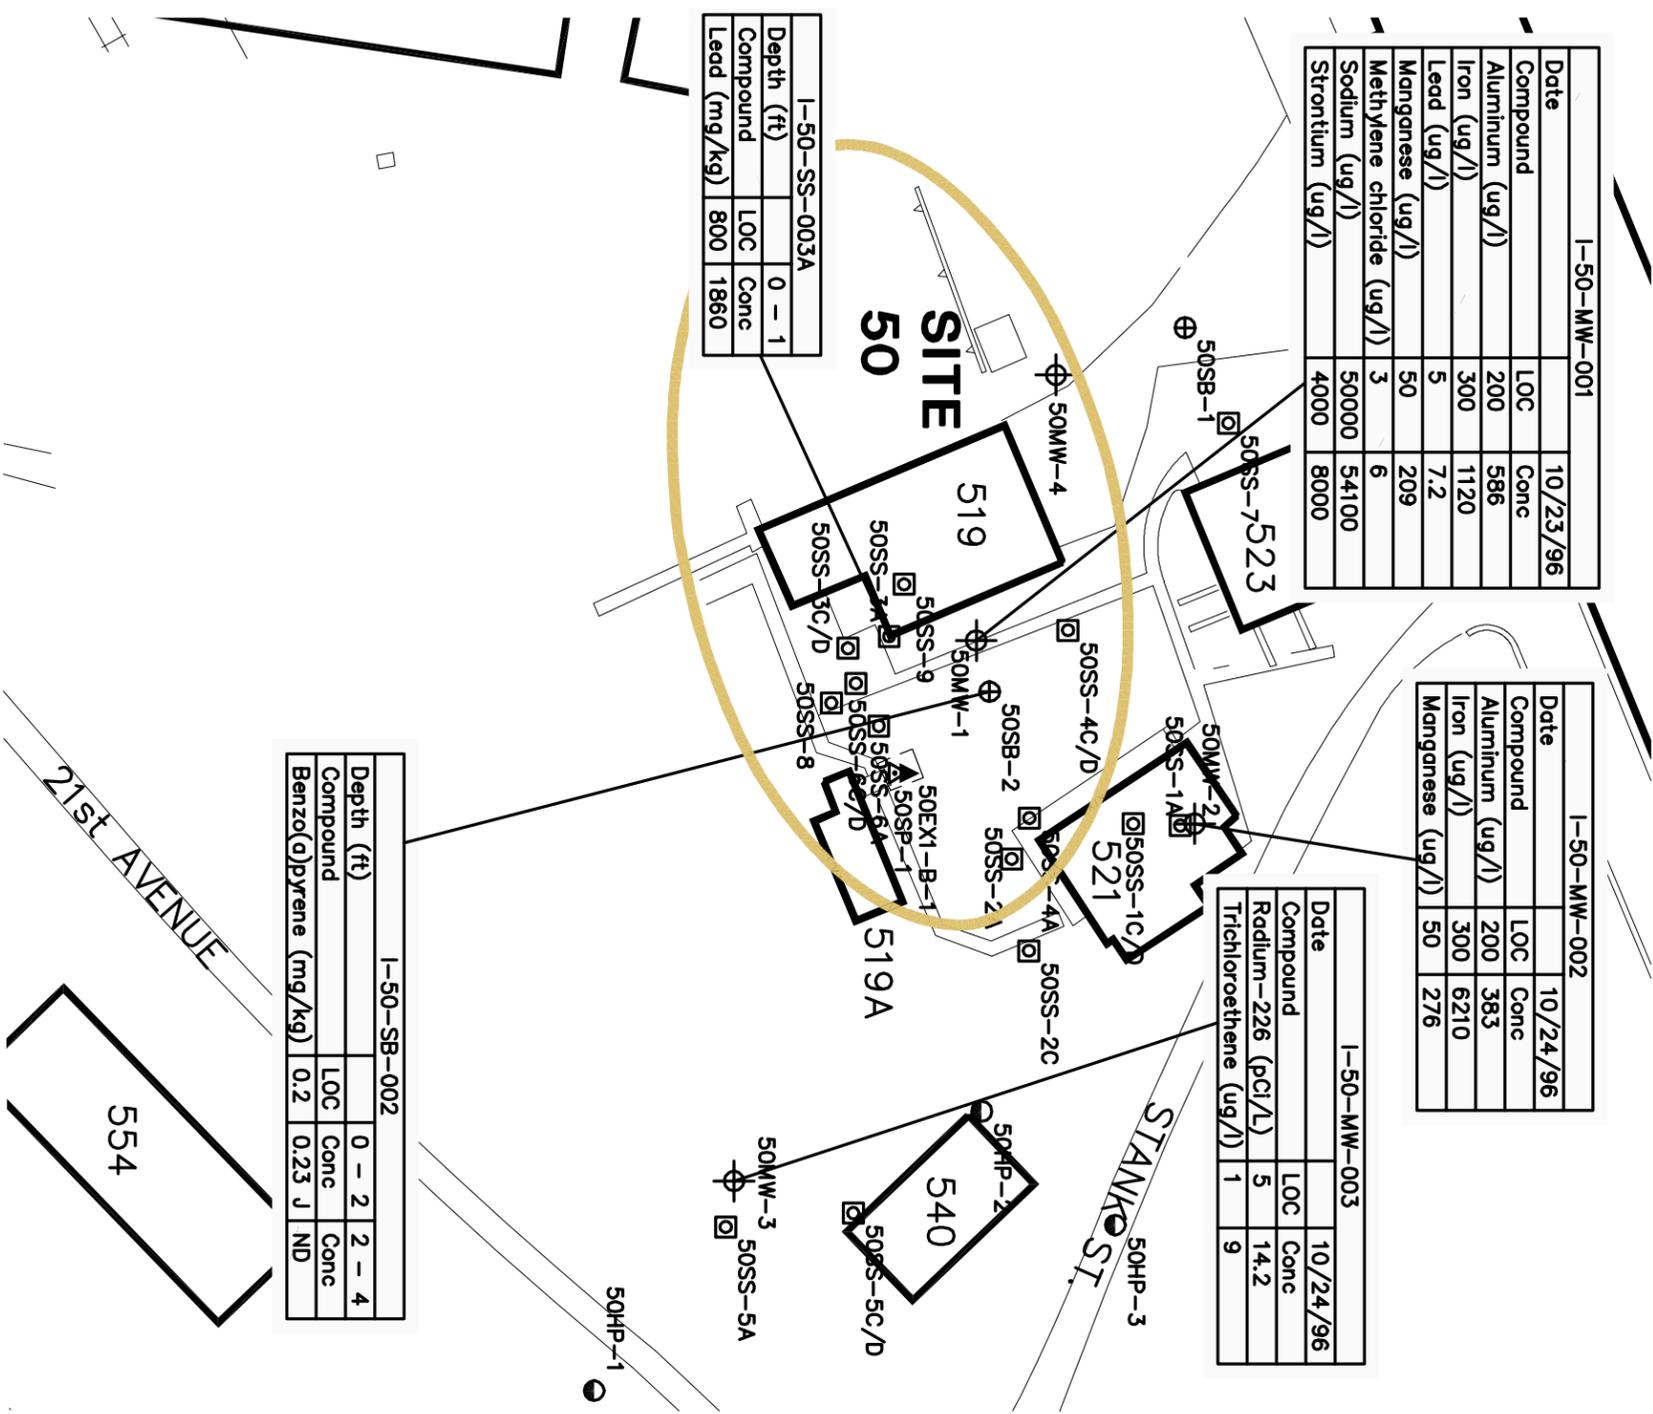
SHEET TITLE: HISTORICAL DATA EXCEEDING LOCs AT RI SITE 50/PICA 022 STILL HOUSE AND HAZARDOUS WASTE STORAGE TANK

I-50-MW-001

Date	LOC	Conc
10/23/96		
Compound		
Aluminum (ug/l)	200	586
Iron (ug/l)	300	1120
Lead (ug/l)	5	7.2
Manganese (ug/l)	50	209
Methylene chloride (ug/l)	3	6
Sodium (ug/l)	50000	54100
Strontium (ug/l)	4000	8000
